# Manhole Inspection Summary

Manhole # S09II2002MH

**Location** Address: **6509 EDENVALE RD**

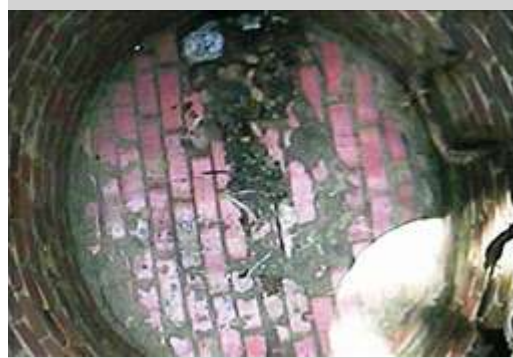
Top View

Barrel infiltration. Corroded steps. Channel debris.

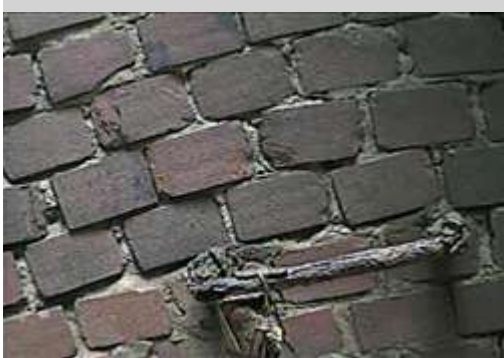
Evidence of surcharge

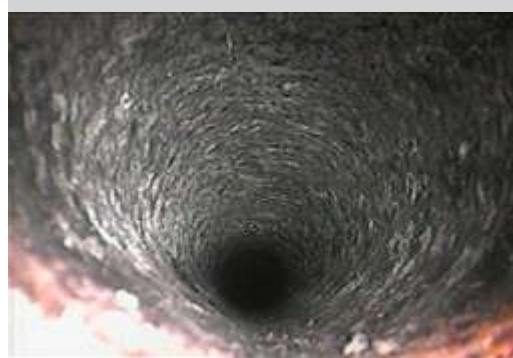
Inside the I6

This goes down the hill towards the County.

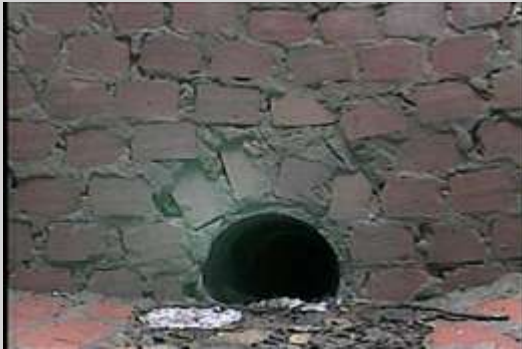
Pipe Out @ 12 O'Clock

Barrel deterioration and infiltration.

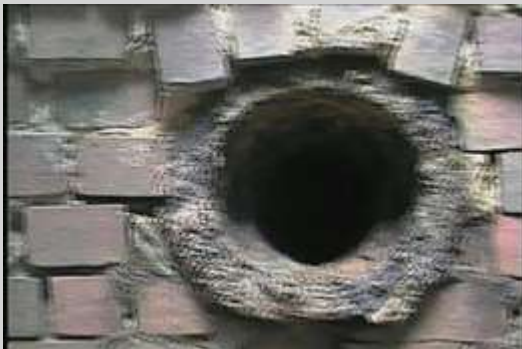
Pipe Out @ 6 O'Clock

Corbel deterioration.
